# Manhole Inspection Summary

Manhole # S25II1006MH

Insp Date: **12/12/06 2:03 PM**

**Location** Address: **1025 43RD ST**

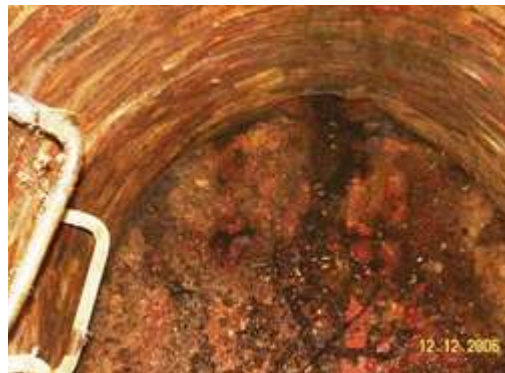
Top View

☒ **Debris** (not Condition related)

Channel debris.

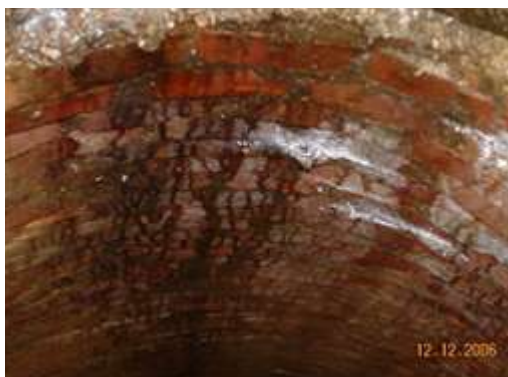
Defect

Offset: **1** (in.)

Infiltration: ☐ None ☒ **Joint** ☐ Cracks ☐ Mortar ☐ Roots ☐ Wall

Frame offset. Adjustment infiltration.

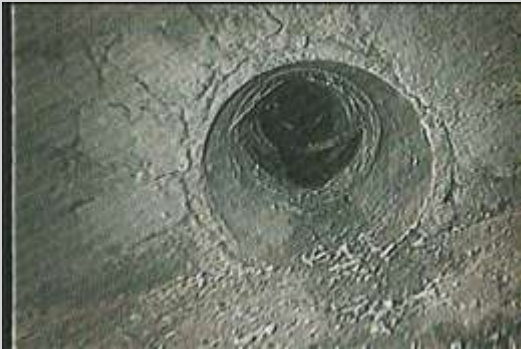
8 in. Circular Gravity Sewer  
Pipe Out @ 12 O'Clock

Deposits: ☐ None ☒ **Mud** ☐ Sludge ☒ **Debris** ☐ Grease

Infiltration: **Evidence** Pipe Seal Cond: **Cracked**
